Case Study

Corrosion Cure – using outstanding anti-corrosive waterborne coat as part of paint system for tank floated roof maintenance

Ponton Floated
roof – Oil Storage
Tank

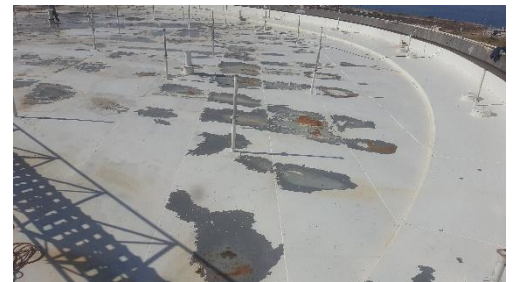
The Client is an energy infrastructures company providing storage and transport services as well as port services for energy products for domestic and foreign customers. The company was established in 1968 and has dozens of large volume steel tanks. The proximity to the seashore and to a coal-based electricity facility are responsible for accelerating the rusting process and for more frequent maintenance.

Floated roof initial condition

The surface of the float roof was cleaned by high pressure water jetting (over 500 bar) to remove old paint and loose metal. Once the area was dry, **Corrosion Cure** was applied by airless spray over the old paint. The required WFT was fifty microns. **Corrosion Cure** has white-off white color (the old top paint was white). A pigment was added to the product to verify that all surfaces had been coated. Twenty-four hours later, a new polyurethane top paint layer was applied to complete the customer paint system requirements. Gloves and protective glasses were the only personal protective equipment required, even respiratory masks were not necessary.

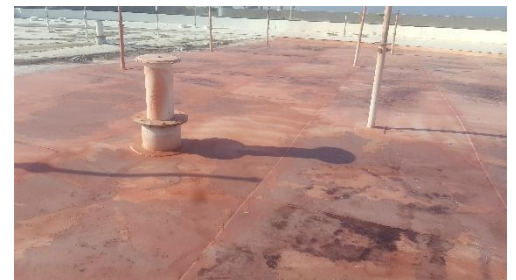
Pigmented Corrosion Cure

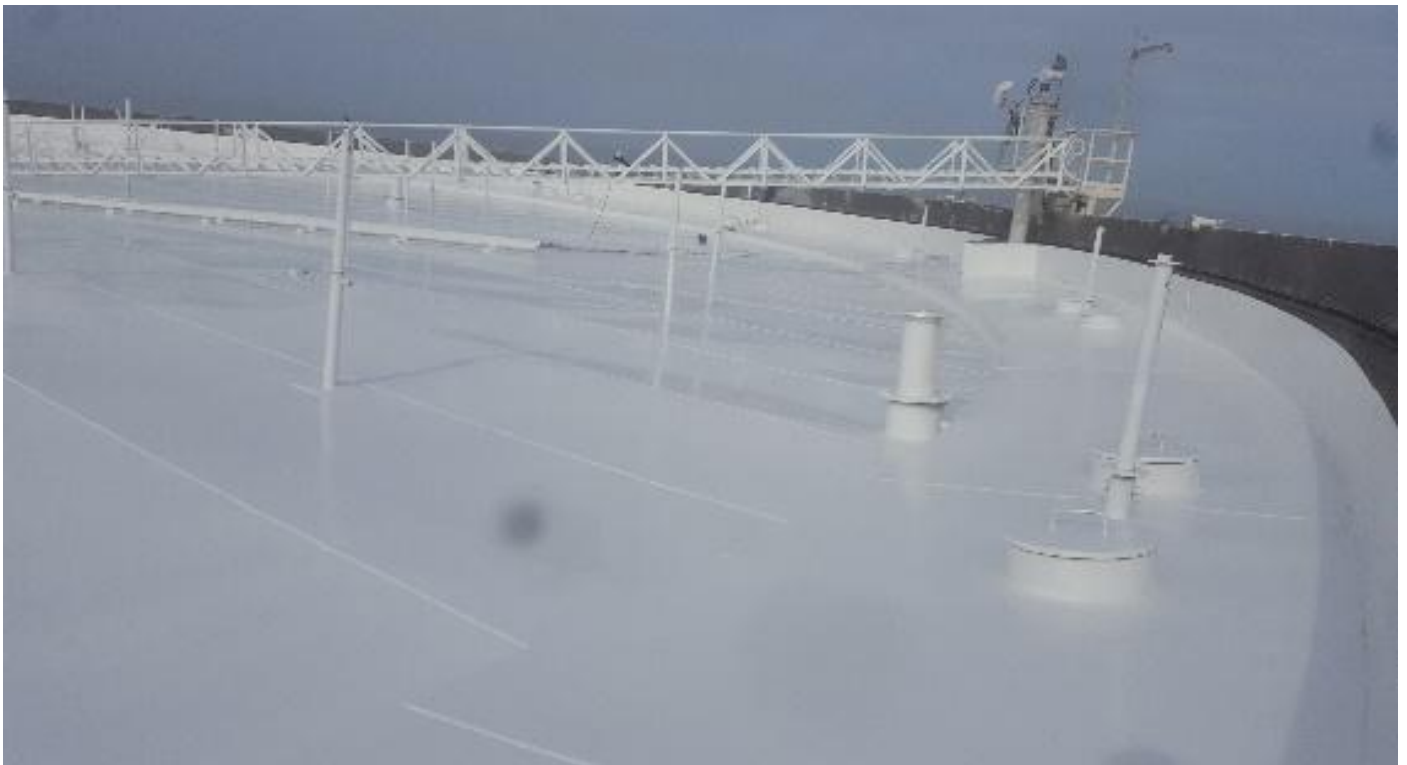
After over a year, the floated roof is in excellent condition. There is no sign of rust or paint lamination. Also, the DFT remains the same and the adhesion is very good.

According to the maintenance manager and the inspector: *"After more than a year, the ponton's roof was inspected and there is no sign of corrosion on the base metal. We also applied it over different surfaces in the plant and the results were also very good".*

Floated roof appearance after polyurethane top paint
