HOW DOES CORROSION CURE WORKS?

Evaluation of Corrosion Cure With salt spray an SEM Page 2 of 33

Executive Summary

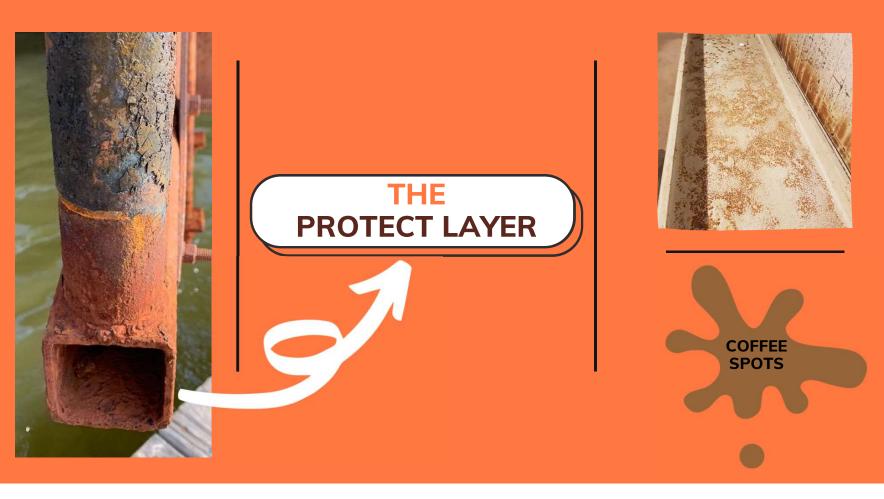
Penetrate into base METAL scavenging

Properties remove OXYGEN

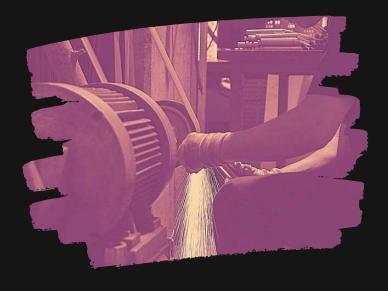
Corrosion Cure Penetrates into Metal (~45 Microns)

CORROSION CURE PENETRATION OF METAL

Days for penetration of 45 microns

Days for Full penetration of metal coupon

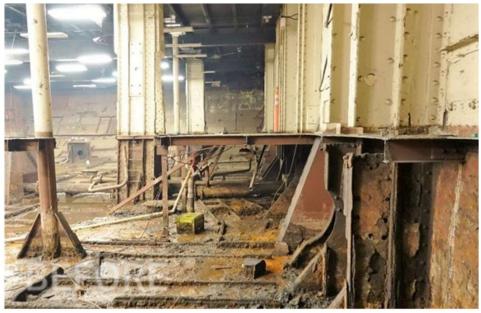
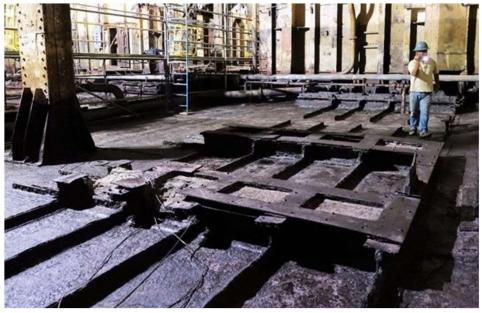
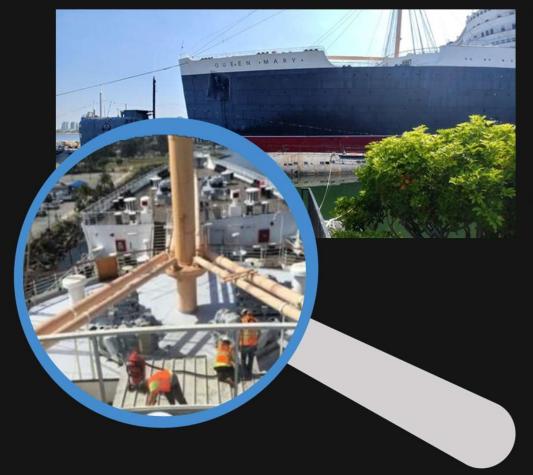
Extreme pitting, shedding, and biological corrosion

Sandblasting, hand tooling, needle gun, were not to be used due to the to conditions of the metal

Project completed under budget due to application process's simple learning curve

Material usage lessened during the length of the job as the crew got more experienced
