Case Study

Corrosion Cure – using outstanding anti-corrosive waterborne coat as part of paint system for maintenance.

**Warehouse
Construction**

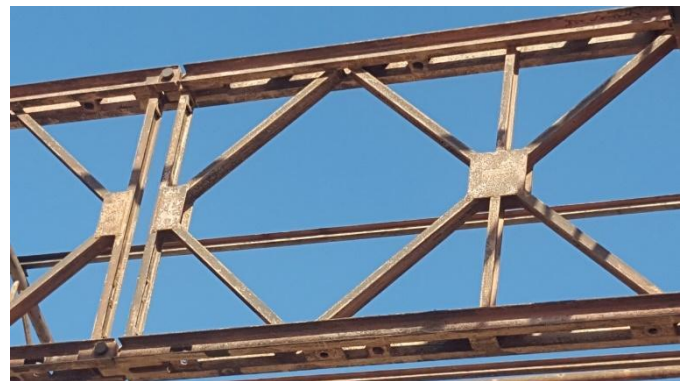
Warehouse's complexity element

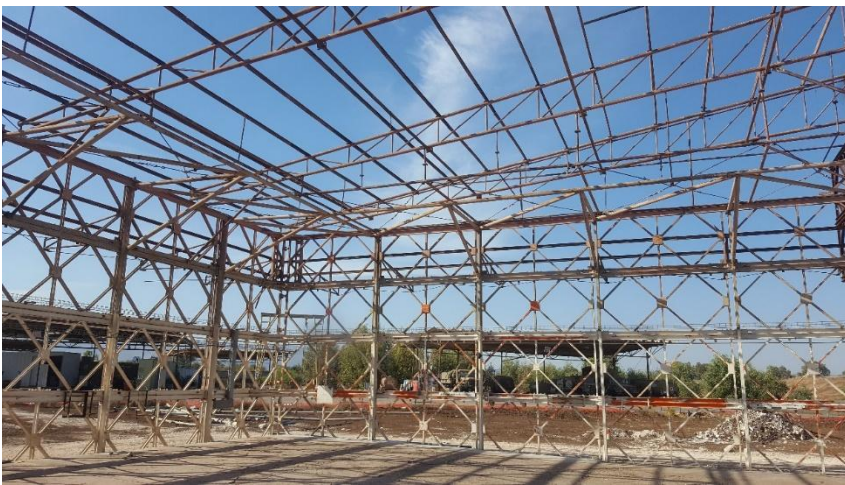
A steel warehouse construction which has not been treated in many years – only renewed the top layer in reachable areas. The rusty condition of the shed had to be treated immediately due to the mechanical strength of the metal itself. In November 2016, Treatment of the shed began and included pre-treatment with high pressure water jetting to remove loose rust and old paint that began to peel off.

shed condition before treatment

The surface preparation was done by high pressure water cleaning (100-200 bars) to remove all loose paint, mill scale and rust. Once the surface dried, the maintenance crew used *Corrosion Cure* coat over the stable rust and old paint. The product has lower VOC (Volatile Organic Compound) ~0 enabling the crew to work free of any special protective equipment against fire. In the end, the product was returned to its original package for additional future uses. Twenty four hours later, they covered the *Corrosion Cure* layer with their common top paints on site.

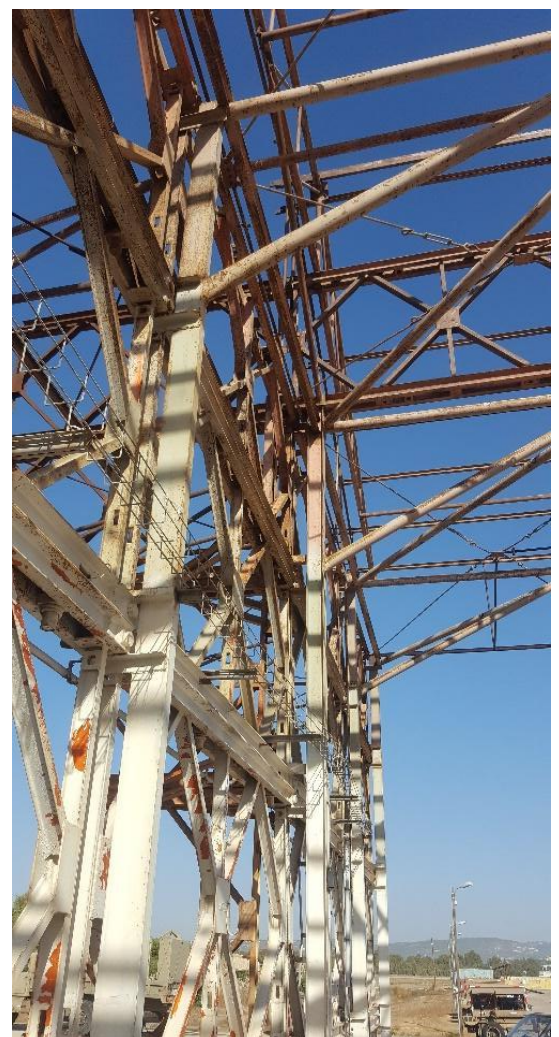
shed condition before treatment

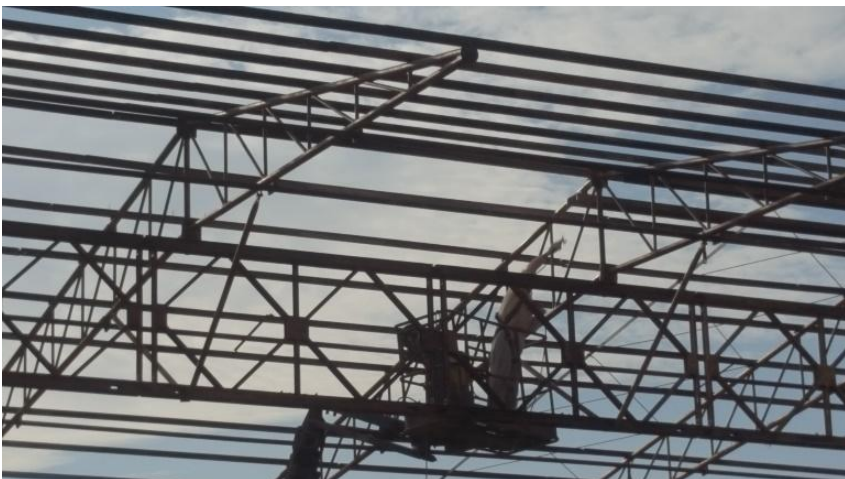
Single layer application with Airless

Once the surface had dried, treatment with the Corrosion Cure began. When the material dries, it becomes transparent, so we add red pigment to the surface material to ensure full application where the paint remains white. Once the base coat finished, the shed was painted with a top coat according to the customer's request. More than a year and a half later, the shed remains in good shape.

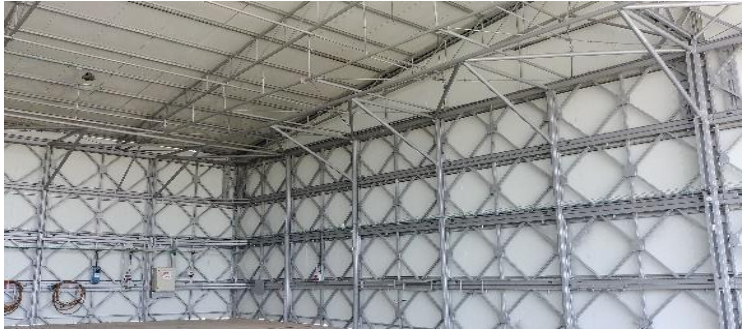
The shed, with a full paint system is in very good condition. No signs of rust spots inside or outside the shed.

shed condition after treatment
